# Texas gas plant faces ongoing battle with oxygen contamination

**Andy Sargent**  
**GAS/SPEC Technology Group**  
and  
**Mike Howard**  
**Duke Energy Field Services**

Duke Energy Field Services (DEFS) is using oxygen ( $O_2$ ) scavenging and ion exchange to battle oxygen contamination at its Wilcox gas plant in Lavaca County, Texas.

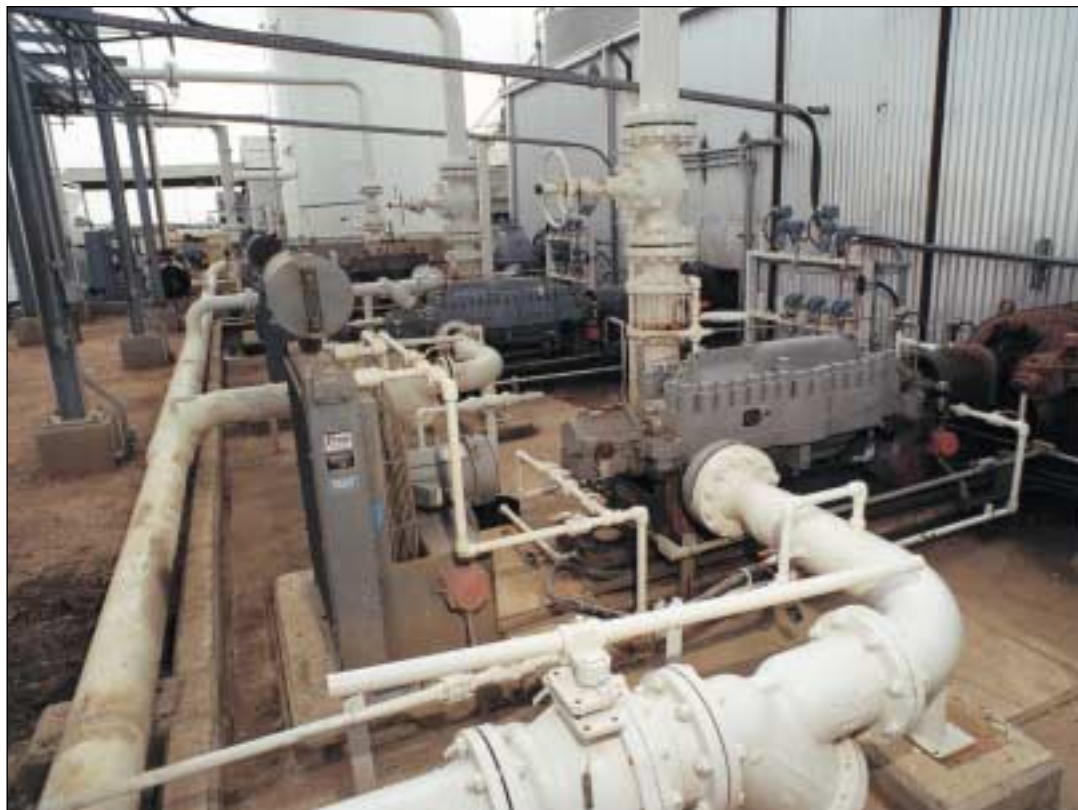
High-pressure amine circulation pumps saw the first problems at the Wilcox gas plant.

Corrosion problems at the plant began about 30 days after start-up. The first problem was failure of the stainless steel (SS) internals of the six-stage, horizontal, high-pressure (HP) amine circulation pumps, which were lean-oil pumps retrofitted for amine service.

After 4 months' operation, trouble was again detected in the amine-circulation pumps. Investigation of these pumps, as well as the rest of the plant, revealed major corrosion in the amine system, mainly to the carbon steel sections of the plant and most notably to the lean side of the plant.

The most significant corrosion was to the carbon-steel housing of the main amine circulation pump. This appeared to be caused by chemical attack. The body and impeller of the ductile iron amine booster pumps also showed significant corrosion in similar fashion to the main circulation pumps.

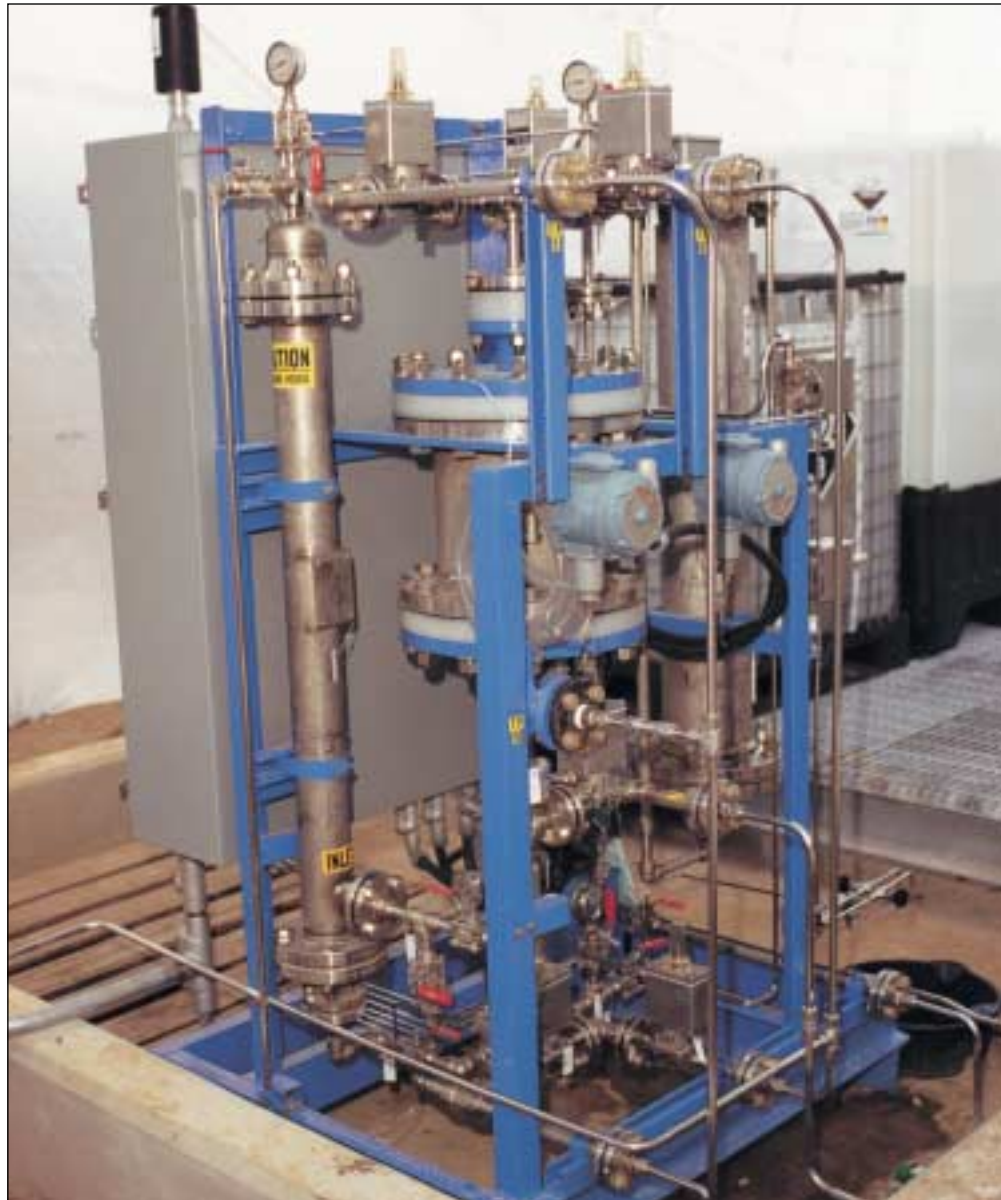
Duke Energy Field Services installed this ion-exchange reclamation unit to remove HSAS and bicine the amine.

The next option considered was ion-exchange reclamation. Ion exchange is effective in removing HSAS as well as bicine from amine plant solutions.<sup>9</sup> An ion-exchange bed and piping were installed to manually reclaim a slip stream of the amine. The bed size installed consisted of 75 cu ft of strong-base anionic resin.

Using the above data, and assuming a bicine buildup rate of 6 ppm(wt)/day (2.1 lb/day), the unit was built to preferentially remove bicine. This unit was installed at the plant in August 2000 and is currently being implemented.

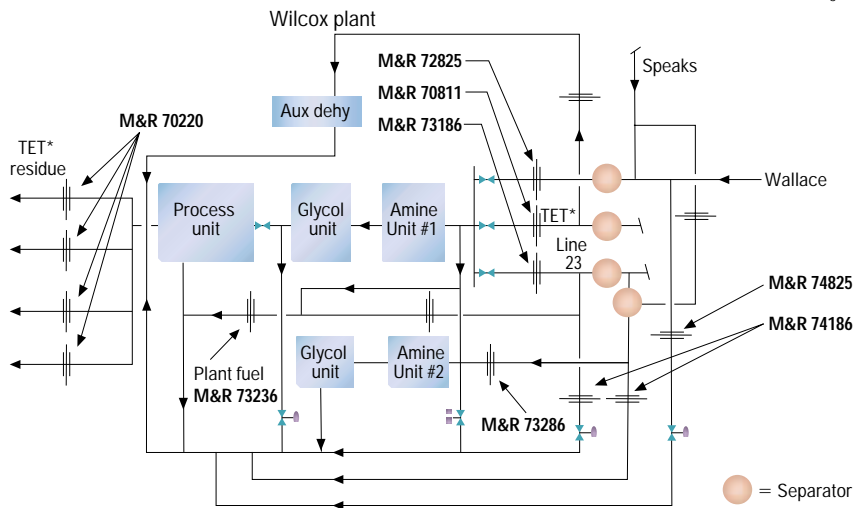
Fig. 1

same amine and regeneration system as the main absorber (Fig. 1).

## PLANT BLOCK FLOW DIAGRAM

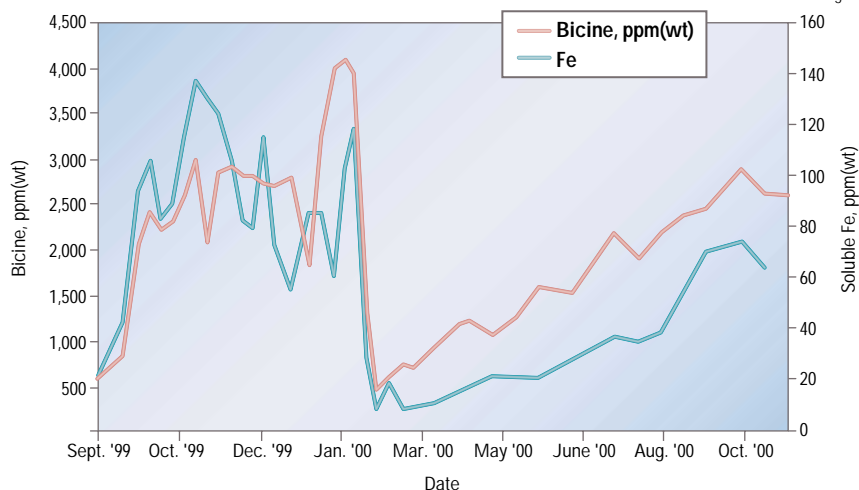
Fig. 2

Was the bicine causing the plant's severe corrosion? A review of the amine analytical data found that the bicine level closely trended the soluble Fe for the data (Fig. 2).

Research supports the trend in Fig. 2, noting that bicine has been shown to be potentially corrosive toward carbon steel.<sup>9</sup> Since the plant was mainly experiencing corrosion in the carbon-steel sections, the root cause of the corrosion was determined to be bicine formation due to O<sub>2</sub> degradation.

## BICINE AND FE LEVELS

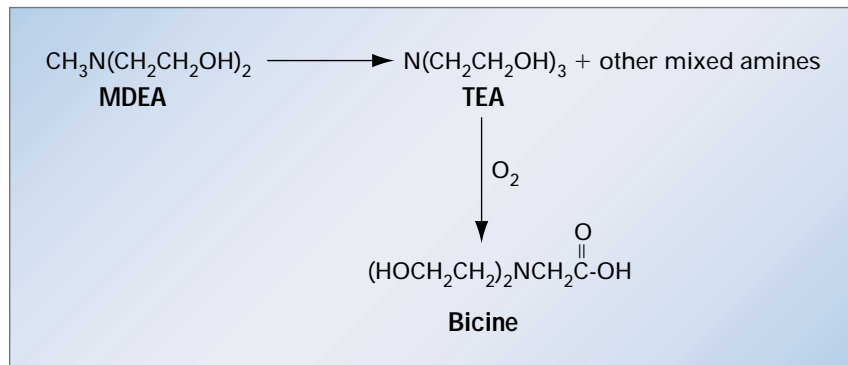
The fourth, and most likely, pathway to bicine involves a disproportionation reaction of MDEA to TEA and other mixed amines (such as DEA and MMEA) and further oxidation of TEA to bicine (Fig. 3).<sup>5</sup>

### BICINE FORMATION

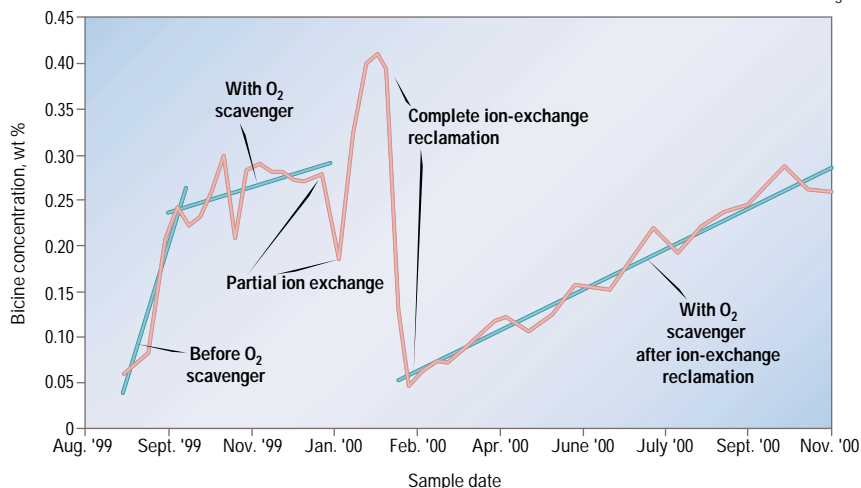
### BICINE BUILDUP RATE

would prevent further degradation. As Fig 4 shows, the scavenger greatly reduced the bicine buildup rate from 60 ppm(wt)/day (21.1 lb/day) in September 1999 to 6 ppm(wt)/day (2.1 lb/day) in October-December 1999 until the solvent was reclaimed via ion exchange.

appeared to be a spike in bicine level. During this same time period, a miscommunication caused a shutoff of the inhibitor flow to the plant. This spike in bicine was caused by the lack of inhibitor flow.

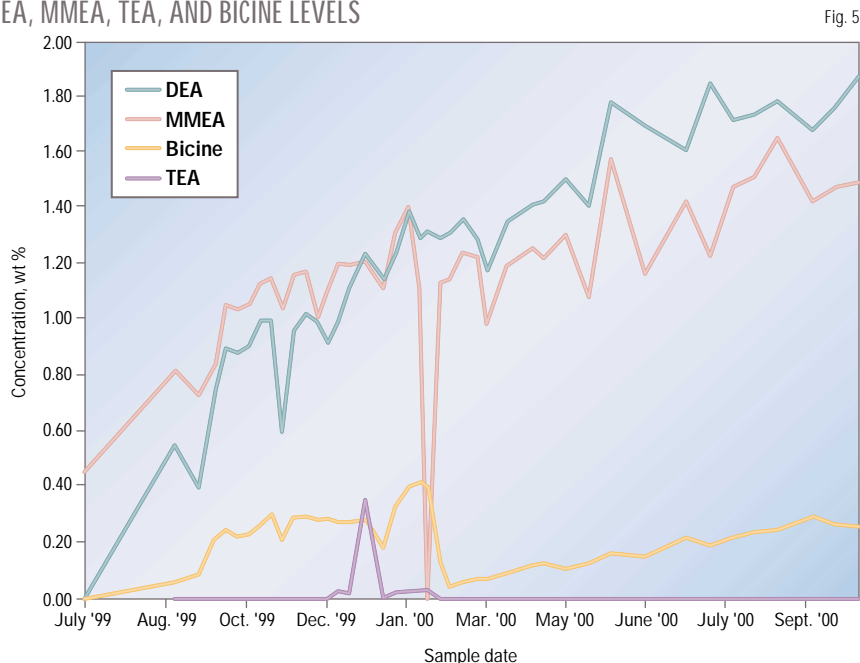
## DEA, MMEA, TEA, AND BICINE LEVELS

was effective in reducing the bicine buildup rate, it was not effective in slowing or stopping the formation of secondary amines, such as DEA and MMEA (Fig 5). The TEA level remained very low in the system, but it is believed this is because the reaction of TEA with O<sub>2</sub> to form bicine (Fig 3) is quicker than the rate of formation of TEA from MDEA degradation with O<sub>2</sub>. Therefore, the TEA will not remain in the system but be converted to bicine.

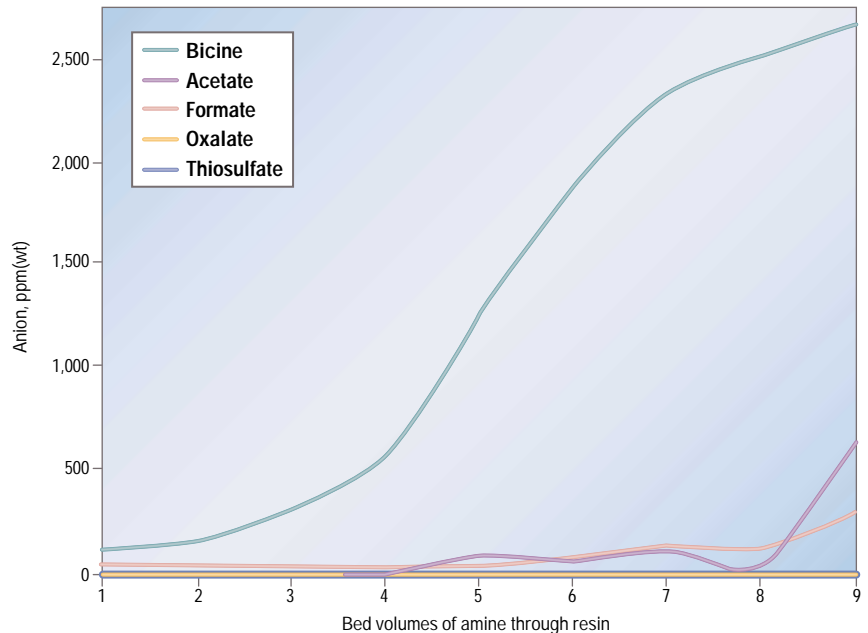
## ANION LEVELS DURING ANIONIC EXCHANGE TREATING CYCLE

Fig. 6 shows the anion levels of the treated amine stream with each bed volume of amine. As can be seen, the treated bicine level increases with each bed volume to a much greater extent than the HSAS. Therefore, to remove the bicine effectively, the ion-exchange treating cycle had to be shortened over the typical cycle time required to remove only HSAS.

Also, the resin would require more-frequent regeneration. That means a much larger ion-exchange unit than would be needed to remove the same level of anions, assuming only HSAS.
